The “Look-See” Crash

Flying an approach to take a look requires the utmost in mental awareness and discipline.

By Wally Roberts

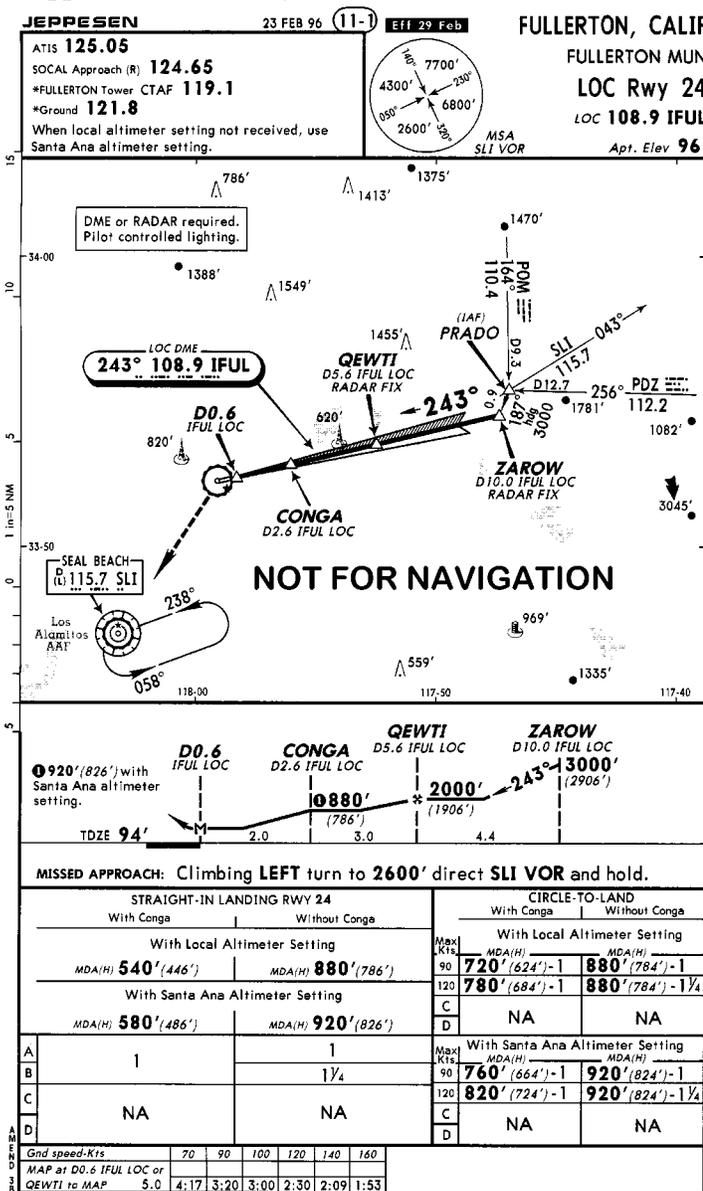
N8JK wasn't DME-equipped. Therefore, the pilots were bound to the higher minimums. Using the Santa Ana altimeter, their MDA should have been 920 feet. The tops of the fog (700-800 feet) were actually below the MDA.

The FUL Localizer Runway 24 approach is a demanding non-precision IAP. The descent gradient from the FAF to touchdown is 381 ft/nm, which is close to the TERPs maximum of 400 ft/nm. There is the added complexity of the application of remote altimeter setting criteria, which apply when the tower is closed. The descent gradient after the Conga step-down fix exceeds TERPs criteria when the remote altimeter setting additive is applied. [(920-94)/2.0 = 413 ft/nm]. (See “Steep Descent Gradient” following this article.)

Note that the altitude before crossing Conga is also the MDA for aircraft without DME. This non-DME MDA is 786 feet HAT when using the local altimeter setting. When the actual flight visibility is at the minimum of 1 sm for Approach Category A, a pilot would be required to maintain the MDA until 1 sm on final approach, because there are no approach lights to reach out and trigger FAR 91.175(c)(3) prior to having one of the runway visual cues in sight.² This translates to a visual segment descent angle of almost 8.5 degrees, a sig-

IFR Refresher reported its concerns to the FAA about the excessively steep descent gradient at Conga when using the Santa Ana remote altimeter setting. On July 19, 1996, the FAA issued the following FDC NOTAM in response to our findings: !FDC 6/5040 FUL FI/T FULLERTON MUNI, FULLERTON, CA. LOC RWY 24, AMDT 3B.

ADD NOTES: WHEN SANTA ANA ALSTG USED, INCREASE ALT AT CONGA/I-FUL 2.6 DME 40 FT. WHEN SANTA ANA ALSTG USED, S-24 AND LOC/DME MINIMA S-24 NA.
