“What The Hell Did We Hit, Man?”

These two pilots ignored the final segment step-down fix during a VOR approach, with tragic results.

By Wally Roberts

Flight Path Profile
Ce-550 Citation
MARCO ISLAND, FLORIDA
31 DECEMBER, 1995

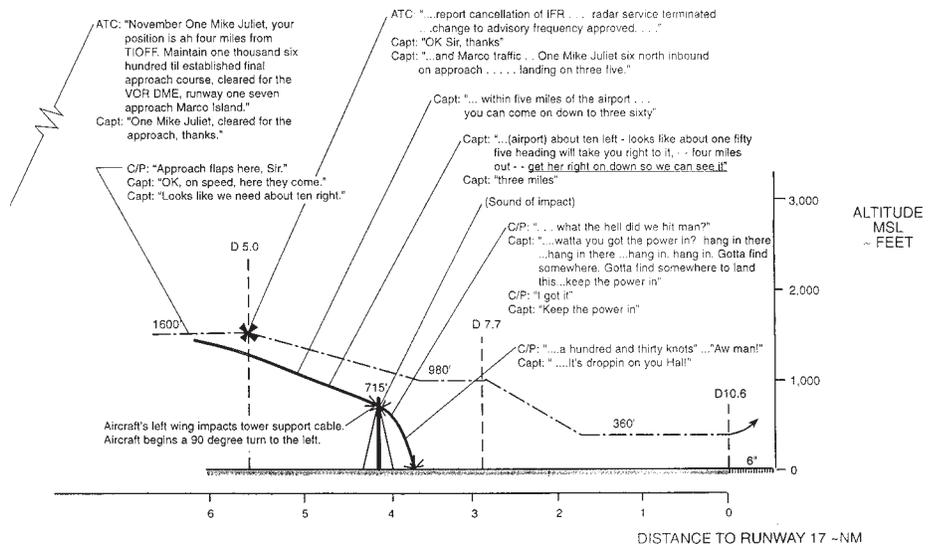
THE TITLE OF THIS ARTICLE isn't from some B-movie screenplay. Rather, it's the startled statement by the co-pilot of a Cessna Citation 550 shortly after hitting the guy wire of a 700-foot antenna, which sheared off 8.5 feet of the Citation's left wing. The crew was able to maintain some control for about another 1.5 miles, then the aircraft went into an uncontrolled dive and impacted the ground. The two pilots were killed and the aircraft was destroyed.

CIRCUMSTANCES: Aircraft was positioning from St. Louis, MO. During a VOR DME 17 approach, the aircraft hit a tower/transmission line some 3-3/4 nm from runway 17. A supporting tower cable took 8-1/2 feet off of the left wing.
WEATHER: 800 broken, 1500 overcast, visibility 6 miles in fog, wind 150/12, temp 73/67 F dewpoint
TIME: 12:25 EST
FATALITIES: 2

Flight path profile created by Allied Signal, Inc. Reprinted with permission.

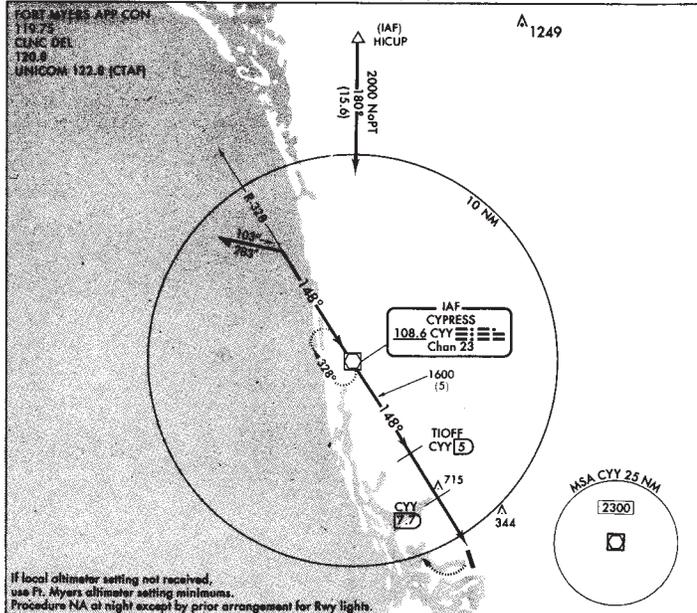
VOR/DME or GPS RWY 17 AL-6449 (FAA)

The NOS chart (left) is the procedure valid the day of the accident. The Jepp chart (right) is the current procedure.

If the crew had the chart available, it should have been the Jeppesen chart in effect on the day of the crash, based on the fact the crew used Jeppesen charts. The Jepp chart (unlike the NOS obscure portrayal of the 715-foot tower) clearly showed the tower in the same graphical manner as the later chart on page 3. This should have been a real clue as to the purpose of the step-down altitude.

Even had the tower not been charted, proper use of the step-down fix would have handily avoided the accident. *Proper* use of the step-down requirement would have meant the minimum altitude from TIOFF to D7.7 was 1,060 feet, not 980 feet because the local altimeter setting was not available (note the charted Ft. Myers' remote altimeter setting requirements both for crossing the step-down fix and for minimums). This point was glossed over by the NTSB in its accident report.

In reality, both pilots disregarded the minimum altitude (not the MDA) for the approach segment from TIOFF to the 7.7 DME Fix. The pilots were only authorized to descend to the applicable MDA *after* crossing the step-down fix. Using the Ft. Myers altimeter, they should have maintained 1,060 feet from TIOFF to 7.7 DME, then descended to the MDA of 500 feet in order to circle to Runway 35.

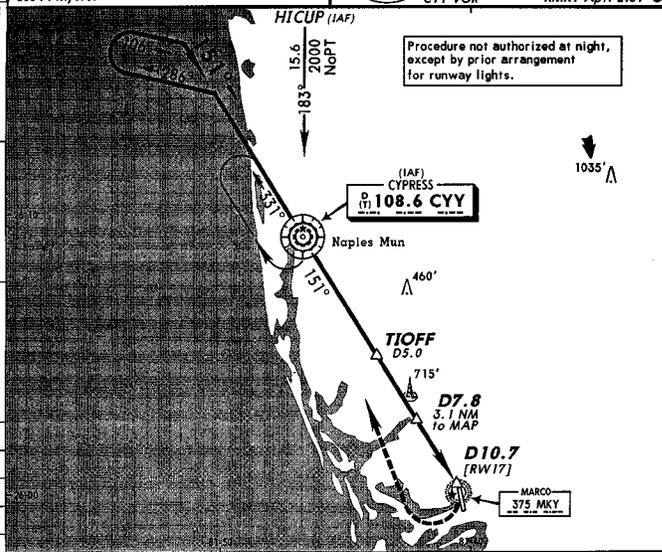
VOR/DME or GPS RWY 17 26°00'N-81°40'W
Amdt 5 MARCO ISLAND, FLORIDA MARCO ISLAND (MKY)

The VOR/DME RWY 17 final approach radial was realigned because of magnetic and VOR station changes. The 7.7 DME step-down fix was moved to 7.8 DME, because the 7.7 DME fix didn’t provide full fix displacement protection as required by TERPs for DME fixes. The NTSB missed this fact, although the slight fix charting error in no way contributed to this accident.
